Architectural CONCRETE

A Radio City for Hollywood

Experience with Weakened Plane Joints

East Carroll Parish Courthouse

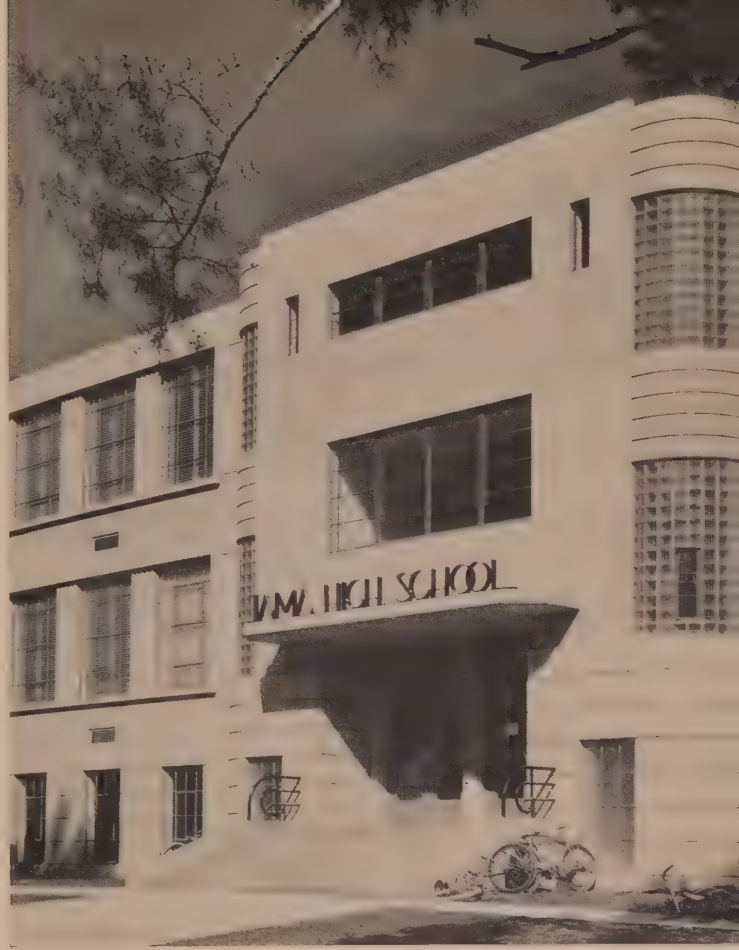
The modern design was kept extremely simple, using fluted piers, projecting bands and rustications to relieve plain wall areas.

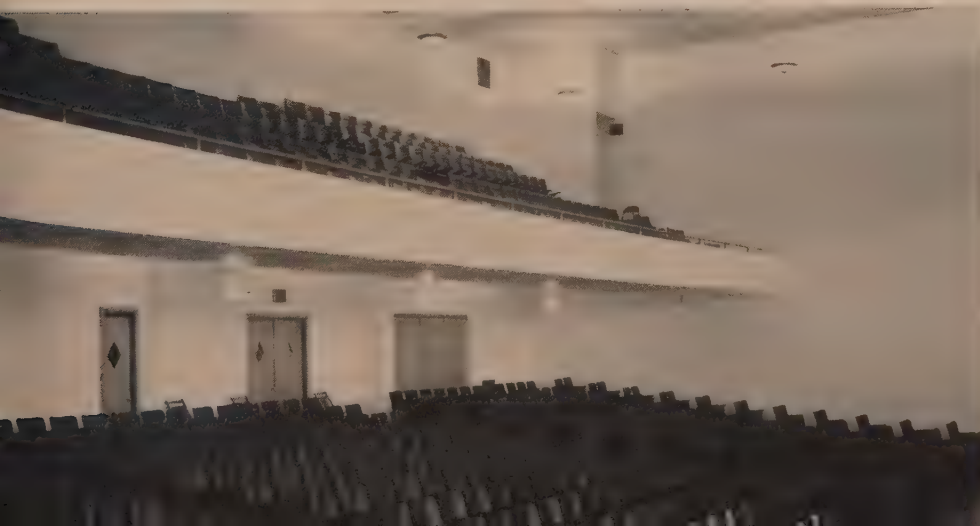
Concrete beams cantilevered from the rear wall of the auditorium support the balcony.

auditorium were made of steel, with concrete-filled treads on which are placed seven rows of opera chairs. The steel work is in turn supported by several large concrete beams which cantilever out 20 ft. from the rear wall of the auditorium. These beams are carried across the corridor at the rear and are anchored securely into the slab of the second floor classrooms beyond. This structural system eliminates entirely the need for objectionable posts in the auditorium.

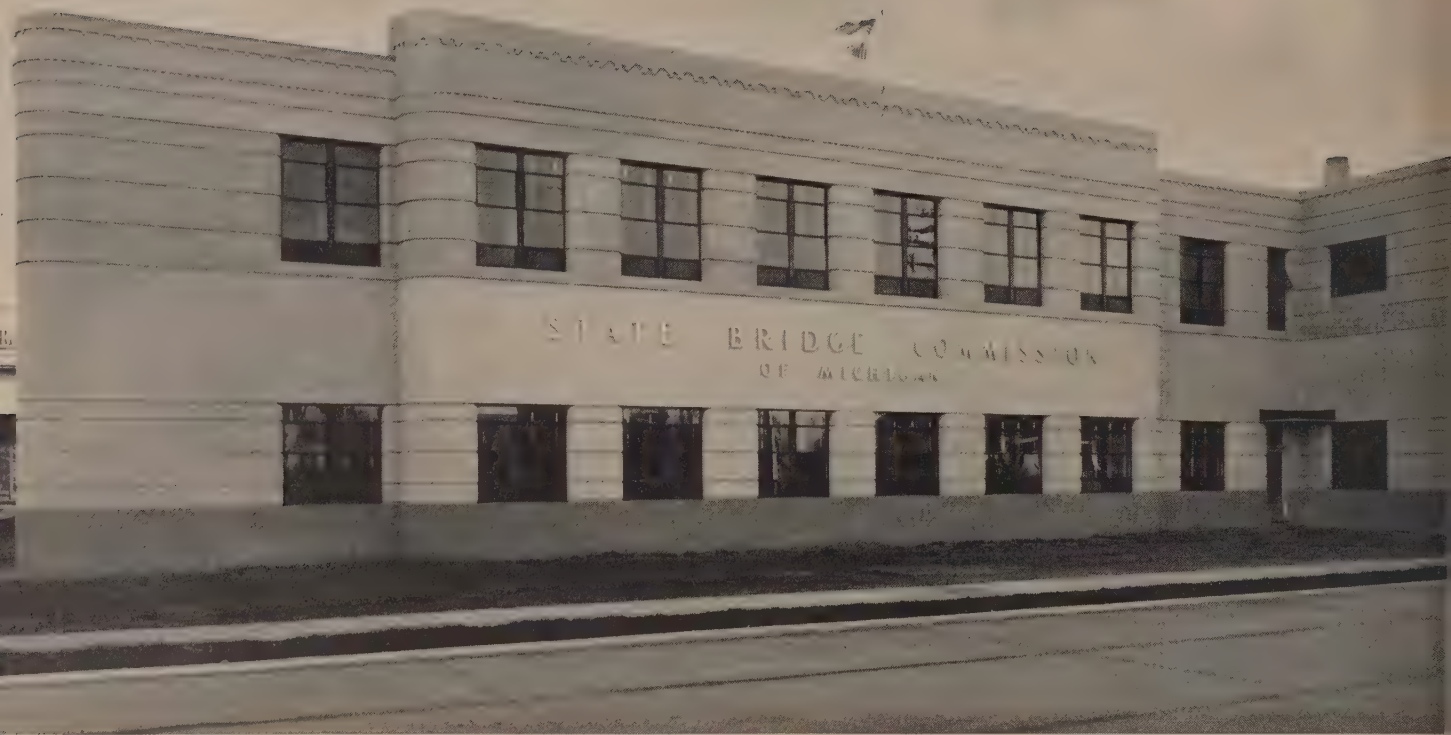
A two-story concrete structure is the administration building at the American end of the new Blue Water Bridge at Port Huron, Mich. Designed by George L. Harvey and Norman B. Forbes, architects, all the buildings were erected by the H. G. Christman-Lansing Co., at a cost of \$236,000.

Architectural concrete walls of the administration building structure vary in thickness to provide ornamentation but are, in general, 14 in. for sections below the first floor, and 12 in. for the remainder of the wall from floor to parapet. The walls are reinforced with $\frac{1}{2}$ -in. round bars on 12-in. centers, vertically and horizontally, in both faces of the walls. Additional reinforcement was used around all openings. The 68-ft. portion of wall embracing the entrances from the plaza is faced with a black cast stone base 3 ft. 6 in.

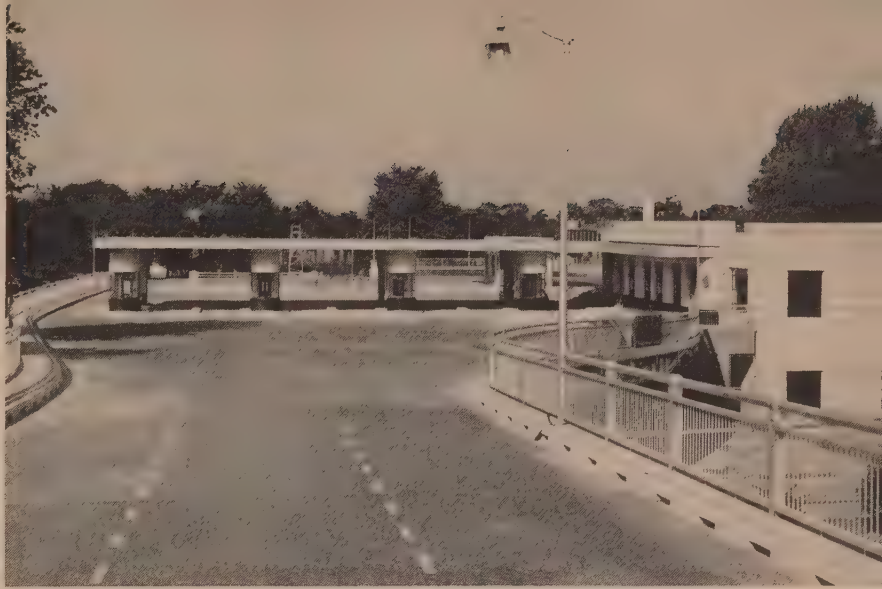
On the plaza the eight toll lanes are served by four inspectors' booths which have black cast stone bases.

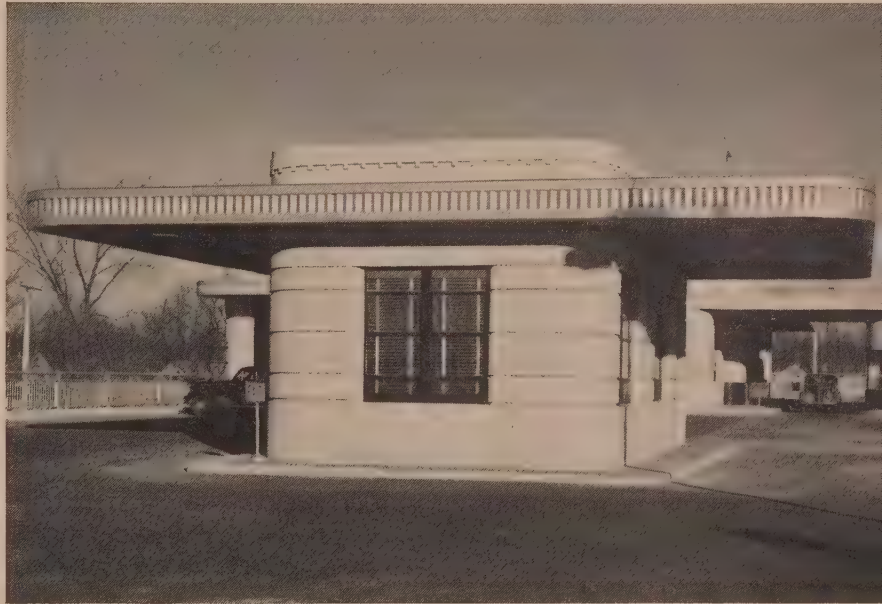
Rustications made convenient locations for construction joints and made them inconspicuous.

Careful formwork produced smooth surfaces and sharp detail. Three-quarter-inch plywood saw-kerfed at 1-in. intervals was bent to a 3-ft. radius to form round corners.

The architectural theme of all the structures follows the modern trend and a streamlined effect was obtained by rounding all corners on a radius of 3 ft. Walls were formed against $\frac{3}{4}$ -in. plywood sheathing which was bent to form round corners by saw-kerfing the back. The dentil course and ornamental band were formed with wood molds. This wood forming, including the 1x2-in. rustication strips, was allowed to remain in contact with the wall concrete after sheathing was removed until it detached itself by shrinking.

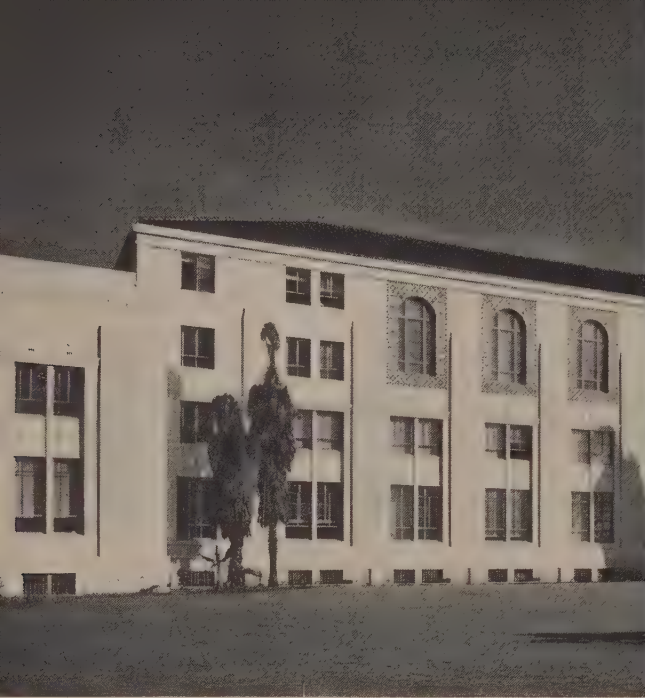
The west facade faces San Diego's harbor from which the building was washed with a white portland cement wash.

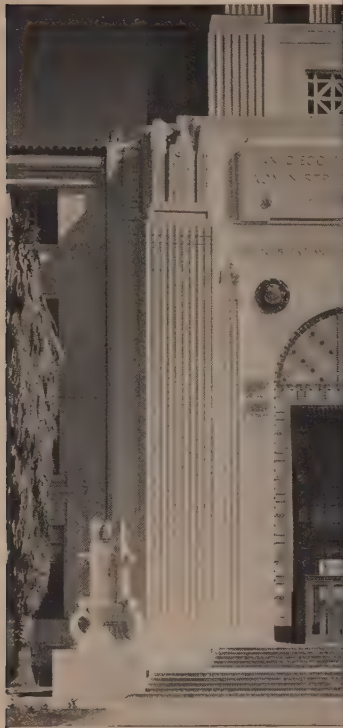
Column capitals and much of the detail were cast in waste molds. Colored tile was used around the entrance.

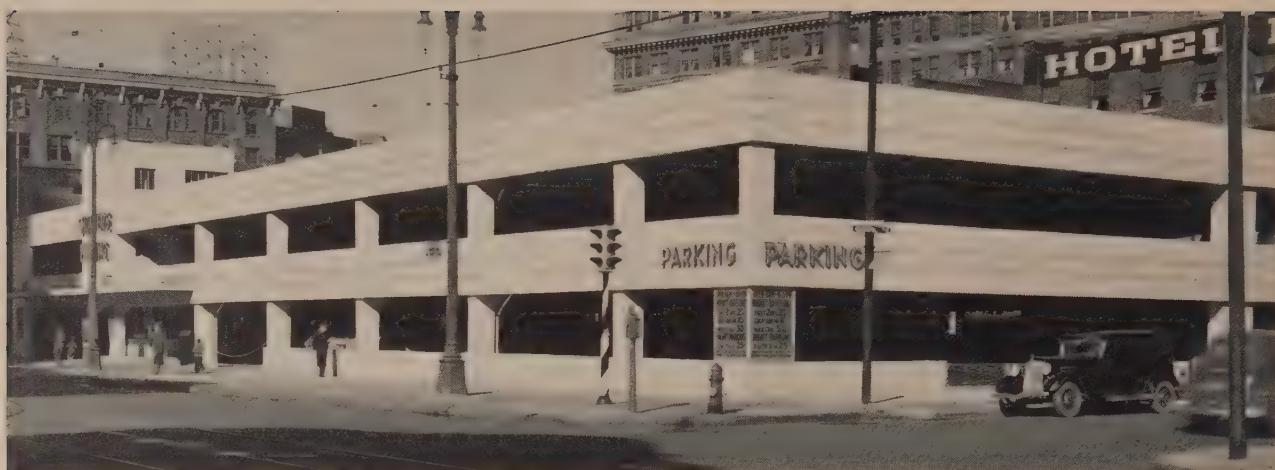
All concrete surfaces of the Shoppers Parking Deck were finished with white portland cement paint.

At column 27 (*see drawing*) beam 315 cantilevers about 22 ft. beyond the column center to pick up the ends of beams 320 and 317 which support ramp area as well as floor areas;

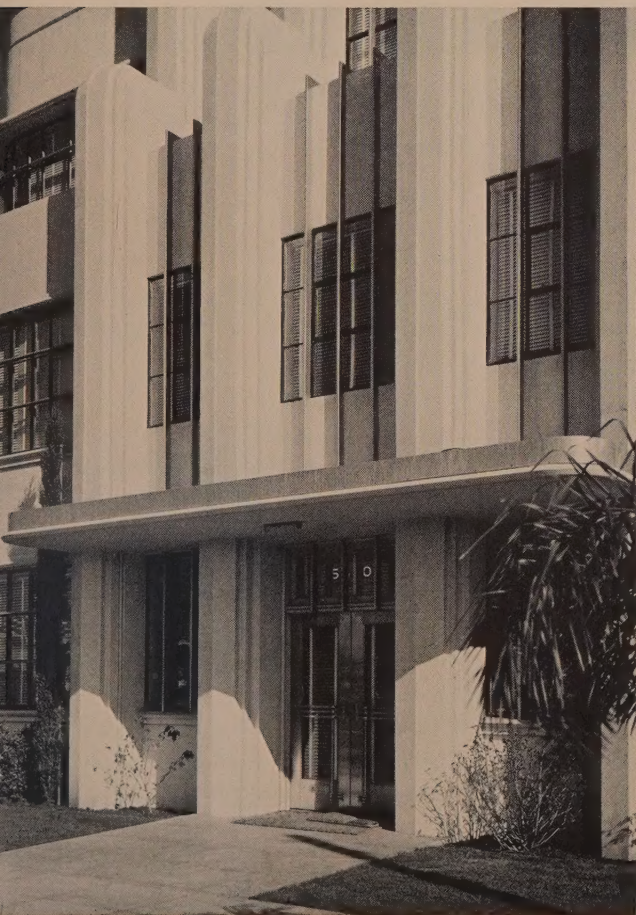
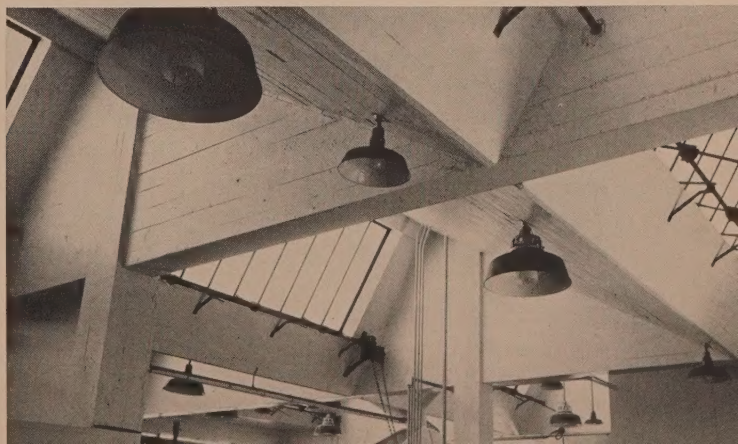
Rounded corners and large continuous glass areas give the buildings a pronounced horizontal feeling, but the tall pylons provide interesting contrasts at entrances.

Saw-tooth concrete roofs provide north light for all the buildings.
